Das Original

TSI 07/10

Tips from the gasket expert Engine failure – is the cylinder head gasket to blame? Overheating on 2-layer metal gaskets

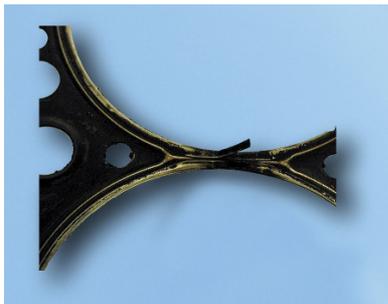
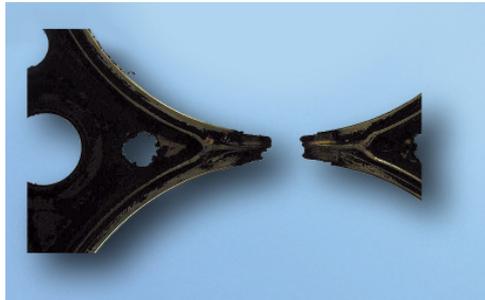
The metallic functional layer into which the combustion chamber seal is integrated is broken in the area of the sealing web. Obvious black discoloration indicates over-blown combustion gas.

Part distortion resulted in over-blown combustion gases, which in turn overheated the metal layers and lead to their destruction.

- Low quality fuel (insufficient octane rating).
- Excessive compression ratio.
- Engine tuning (sparkplugs with incorrect heat rating).
- Insufficient bolt clamp force (bolt quality, tightening of bolts).

Check the condition of the sealing surfaces very closely before installation and ensure that the cylinder head is. If necessary resurfacing by a specialist.
