TSI 10/10

# Tips from the gasket expert Engine failure – is the cylinder head gasket to blame? Oil leakage, sealing compound on sealing element (truck)

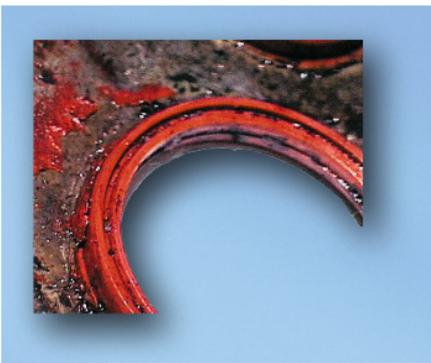
The elastomer sealing element has been pressed away from the carrier plate. Dirt particles are in the sealing groove.

Additional sealing compound was applied to the metal carrier plate. As a result of vulcanization, the elastomer sealing element was subjected to additional pressure and pushed back, causing oil leakage. The damage was accelerated by dirt particles that accumulated from the oil.

- The sealing element was damaged during installation/positioning of the cylinder head.

Check the condition of the sealing surfaces very closely before installation and ensure that the cylinder head is. If necessary resurfacing by a specialist. Do not use sealing compounds. Change oil regularly.
