TSI 12/10

# Tips from the gasket expert

## Engine failure – is the cylinder head gasket to blame?

# Uncontrolled combustion process on multi-layer metal gaskets

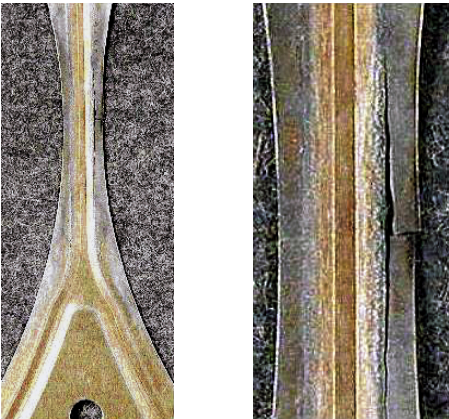
Initial black discoloration in the sealing web area of the functional layer indicates the start of destruction, which is complete in the second picture (right).

An uncontrolled combustion process generated high-frequency vibrations. The resulting shock waves destroyed the sealing web.

- Poor fuel quality (insufficient octane rating).
- Excessive compression ratio.
- Sparkplugs with incorrect heat rating.

Follow the specified installation instructions closely.  
Be certain to use the engine parts (sparkplugs) specified by the manufacturer.
