Gasket, cylinder-head for Engine Repair

195.470 for MAN D20 | **466.600** for MAN D26

SI 02/2023

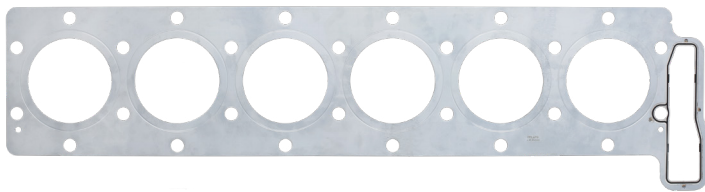
As can be seen in the image, in contrast to the standard gasket it has an additional notch at the front that is also clearly visible when it is installed.

Important: It is extremely important to check the engine components that are affected by this modification (e.g. injection nozzle as a result of an excessive protrusion). We should like to expressly state that we assume no liability for the correct technical execution of the engine repair. This is the responsibility of the firm carrying out the repair work. Always observe installation and manufacturer information.
