Sealing engine components.

Damage caused by incorrect screw tightening

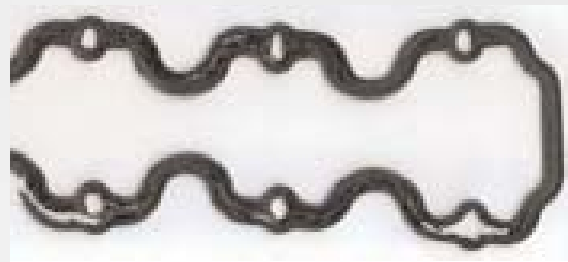
Gaskets for valve covers or oil tanks, for example, are repeatedly being tightened with too much torque to try to press together distorted components. Following the motto: the more torque, the tighter.

But the result is anything but satisfactory. The seal material, made of high-quality elastomeric plastics or plasticizer materials, cannot cope with this force impact, the seal material is damaged, leading to leaks.

Rubber and cork valve cover seal

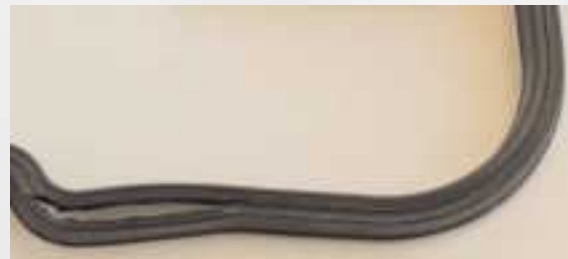
Elastomer oil tank seal

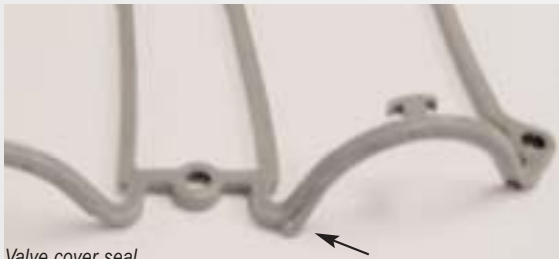
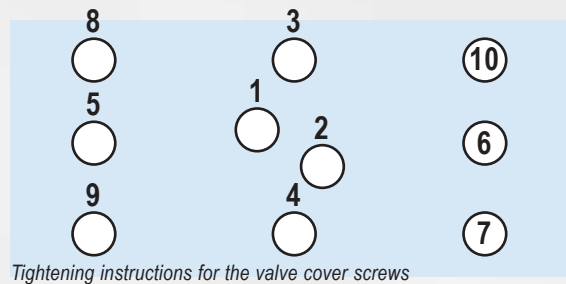
Example: middle segment car

After a short service life, the valve cover of this engine was damaged due to excessive pressing forces on the semi-circular elastomer arch (cf. arrow).

If the prescribed tightening torque had been used

1st opening: 1 – 3 Nm

2nd opening: warm-up time approx. 15 min.

3rd opening: 6 – 8 Nm

this would not have happened.

When assembling the components, always follow the prescribed installation guidelines and test the sealed surfaces for leaks. That is the only way that the seal can do what it is supposed to do.
