A Problem *from the Real World*

Destructive
Heat as the Reason
for Failure of the
Cylinder-Head Gasket

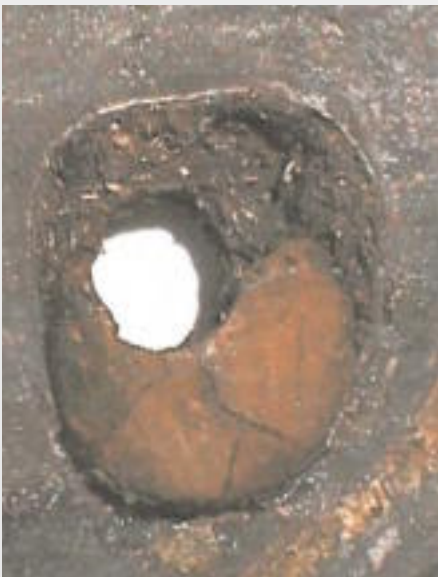
A cylinder-head gasket (metal-elastomer construction) that has failed due to overheating can be identified by the appearance of the elastomer at feed-through openings for water (see fig.). The actual cause for the failure, though, is seldom the gasket. The real culprits that must be identified are often not even taken into consideration, e.g. engine components such as the water pump or thermostat that are functioning only poorly or not at all, or a clogged radiator. Often, the cause is even simpler: too old or improper coolant – this can be avoided from the outset.

*Close-up view
of a failed water feed-
through opening*

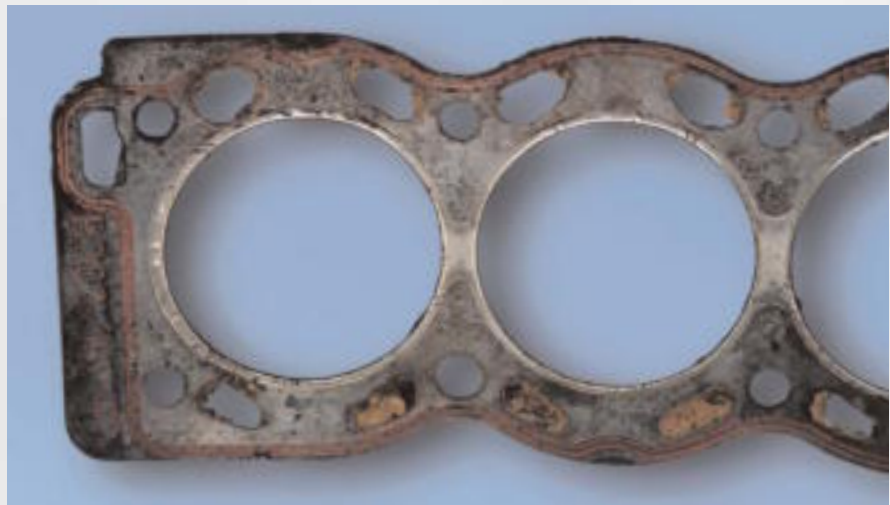
The importance of the coolant is often underestimated. The coolant is needed not only to cool the engine and act as anti-freeze, but also often to protect component surfaces against corrosion – especially surfaces of aluminum alloys such as those that function as sealing surfaces for the cylinder-head gasket. The inhibitors and glycols contained in the coolant are responsible for this. Over time, however, these degrade as the result of the high temperatures encountered in the coolant circuit of the engine – and the specified protection is no longer assured! As corrosion progresses on the sealing surfaces, the cylinder-head gasket gradually starts to fail (see fig.). Checking and replacing the coolant on a regular basis prevents this.

Failed cylinder-head gasket

- Always comply with the operating specifications of the engine manufacturer
- To be perfectly safe, use only the coolants approved by the manufacturer

Remember: Check the coolant – especially during the next inspection before winter. This will prevent costs and frustration.
